PROPERTY INSPECTION REPORT

Property Address	XYZ, Gurugram
QRN Number	910
Client Name/Owned by	Mr. XXX
Property Type	Residential
Inspection Type	Micro level
Inspector Name	Mr. Sumit Kanaujya, Mr. Kuldeep and Mr. Virendra Kanaujia
Project Manager	Mr. Gopal Singh Negi
Date of Inspection	10 April 2018
Time of Inspection	11:00-16:00 Hrs
Area Inspected	Living /Dining, Kitchen, 4 Bedroom, 4Toilet, 4 Balcony, 2 utility balcony, 1 Utility,1 Servant room,1 Servant Toilet

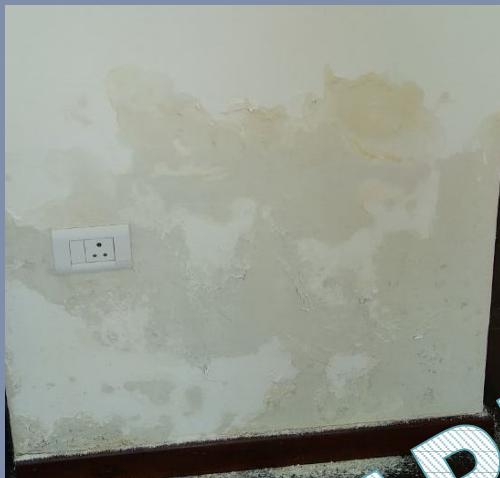
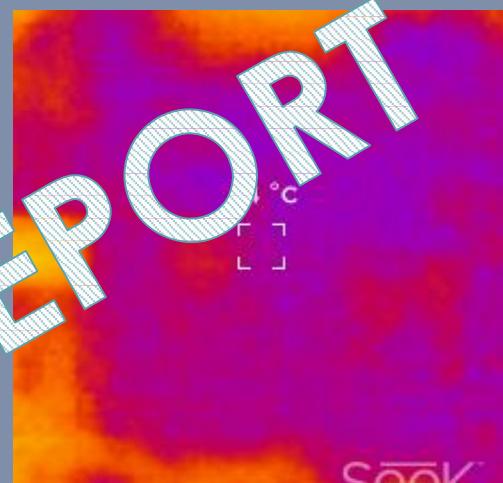
Master bedroom right wall (bathroom door)

Mold observed on right hand side wall of master bedroom, thermal image confirms the same.
Presence of electric socket can be hazardous.

Source- It is due to leakage of water closet in Master bath behind the tagged location.

Suggested Repair- Water Closet should be repaired and **Mouldy grout** and **sealant** should be used in the bathroom or around sinks

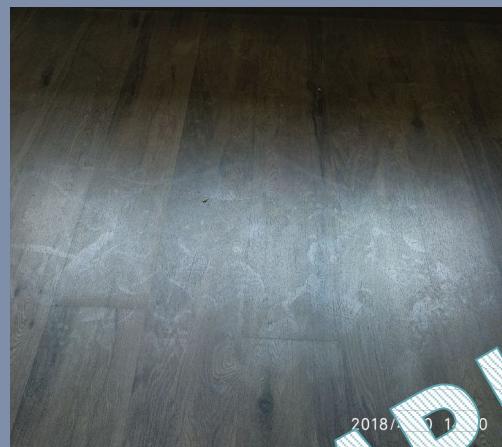
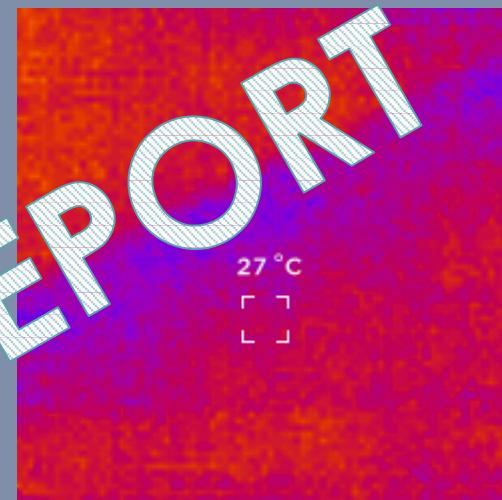
Master bedroom wooden floor

The image confirms the presence of moisture which was hard to see from naked eye.

Source- Moisture is due to leakage in water closet.

Suggested Repair- Wooden flooring should be removed and reinstalled. Use of **Damp proof membranes** (DPMs) are recommended.

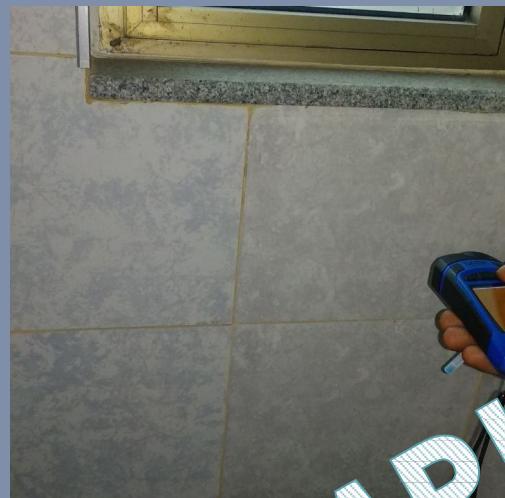
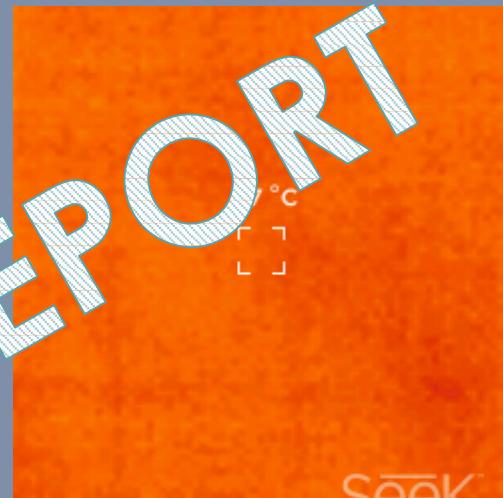
Bathroom 3

No visible leakage in bathroom of bedroom 3.

All the fixtures are in good condition.

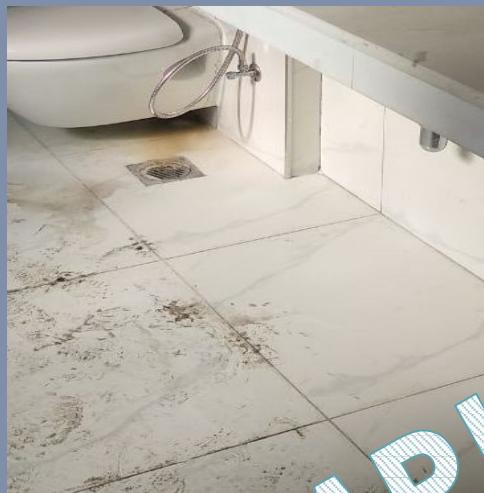
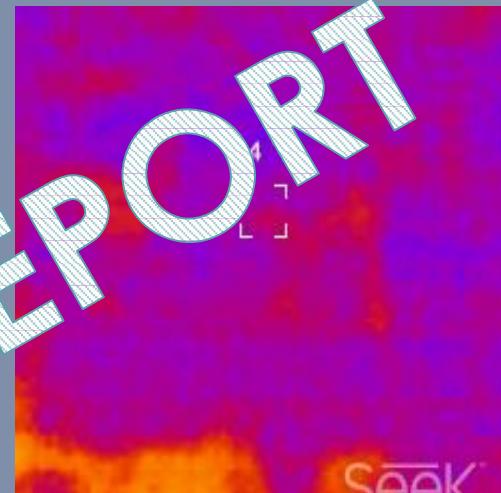
Master bath

Severe leakage and moisture observed in master bath. Thermal image confirms the leakage.

Source- Leakage in water closet

Suggested Repair- Cistern water drain assembly should be replaced and all the inlet and outlet should be sealed properly.

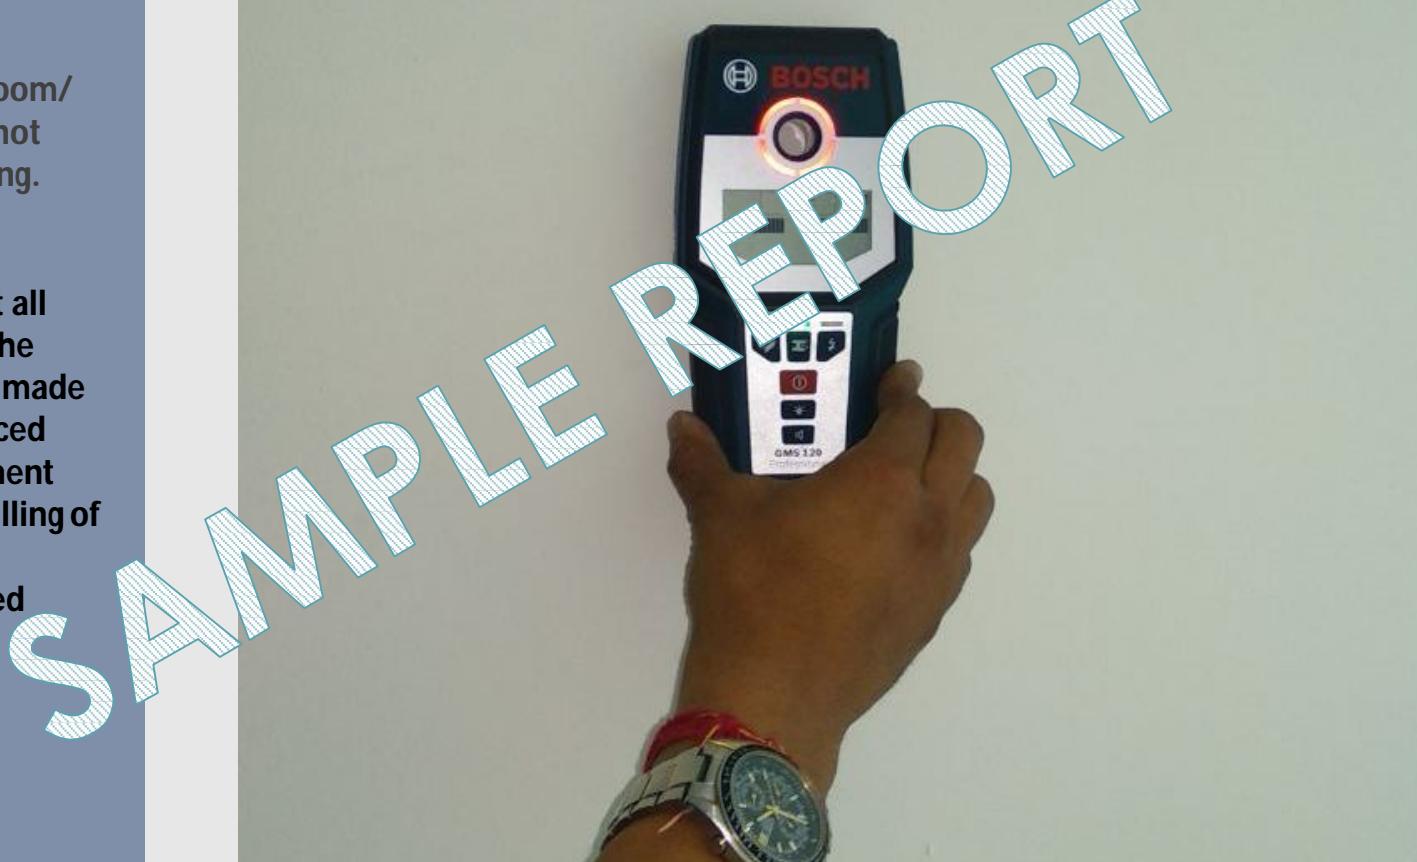
Master bedroom/
front wall is not
safe for drilling.

Note- Almost all
the walls in the
property are made
up of reinforced
concrete cement
(RCC) and drilling of
nails is not
recommended

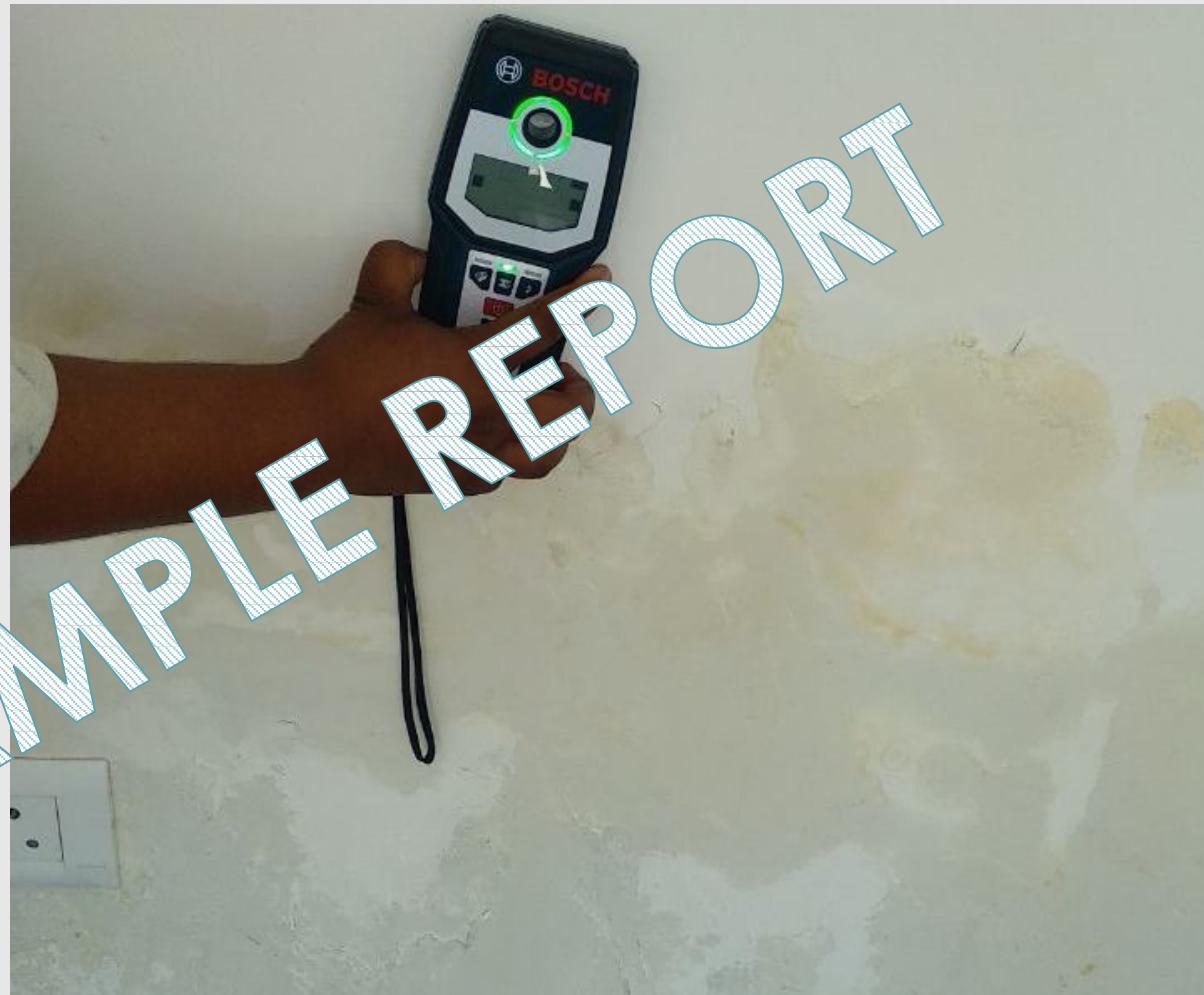
Master bedroom
right wall (beside
bathroom door)/

Location is safe for
drilling for nails.

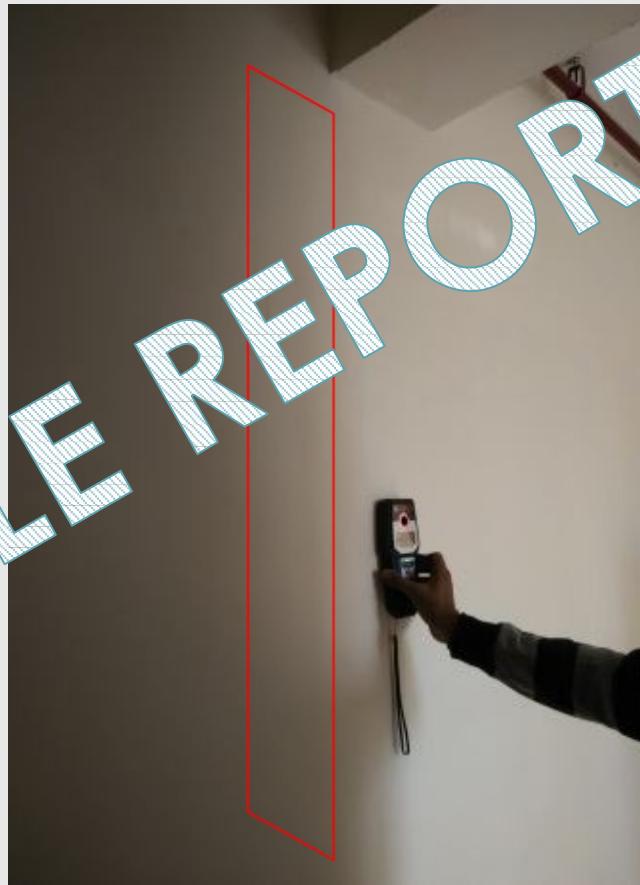
Hall: On right wall
(facing main door)
below beam in
entry corridor
