PROPERTY INSPECTION REPORT

Property Address	XYZ, Gurugram
QRN Number	910
Client Name/Owned by	Mr. XXX
Property Type	Residential
Inspection Type	Micro level
Inspector Name	Mr. Sumit Kanaujya, Mr. Kuldeep and Mr. Virendra Kanaujia
Project Manager	Mr. Gopal Singh Negi
Date of Inspection	10 April 2018
Time of Inspection	11:00-16:00 Hrs
Area Inspected	Living /Dining, Kitchen, 4 Bedroom, 4Toilet, 4 Balcony, 2 utility balcony, 1 Utility,1 Servant room,1 Servant Toilet

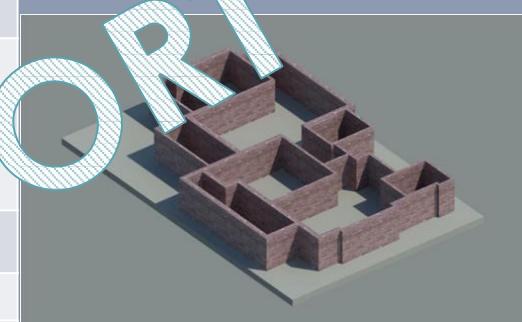
ISOMETRIC VIEW OF FLAT WITH ROOM AREA AND HEIGHT OF FLAT

Dimensions are measured Wall to Wall in complete Flat. Shown Walls does not represent actual walls in Flat
